Hippos (Sussita) Excavations 2010 – 11th Season Daily Log + Drawing

Date: 25 July 10 Area: NEC Manager: Schuler

Squares	YY99	ZZ0			
Loci	1296 1907	1226			
Baskets	2372 2374	2373			
Walls	W1261, W1266, W1288, W1236, W1297, W1298, W1910, W1911				
Floors	F1294, F1909, F1912

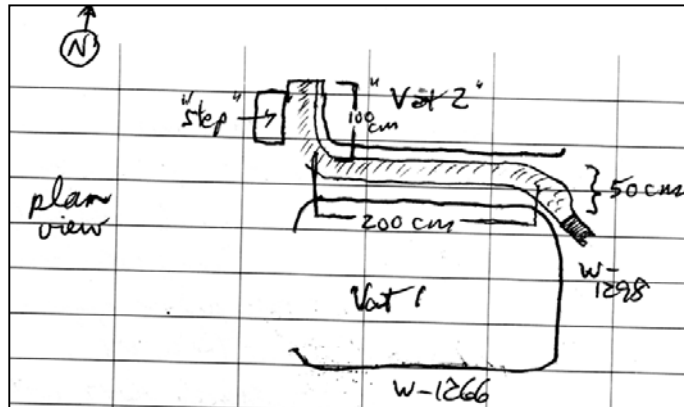
- Over the top of the north wall of the south vat is an open water channel. It originates in a pipe in W1298 about 30cm south of the north wall of the vat. The pipe has an internal diameter of 9cm and runs straight for at least 26cm inside of W1298 The channel is about 15cm wide and 12 cm deep. The water flows north along the wall briefly and then flows west over the north wall of the

south vat. At the column, some of the water is channeled down the west side (toward the cistern?). Part of the channel turns north. Its terminus is uncertain as the plaster breaks down.

- Soil is Horizon C
 - L1907 was previously identified as a vat. Upon removal of heavy fill, it became clear that there is no vat in that location. Rather the northern wall of the south vat comes to an end at a column (2.55m from W1910) and then goes north for 1.40m. It is plastered on the north face. The section jutting to the north has an east facing step/bench (30cmx57cm). The section is possibly an entrance to the space from the street to the east

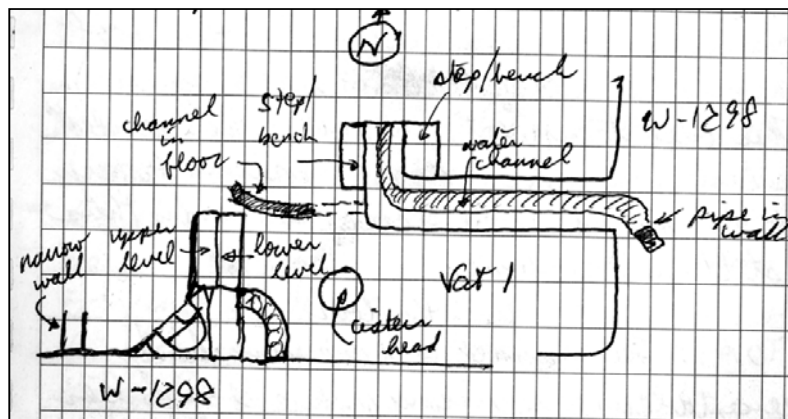
- Near the cistern and 1.65m from W1266 is a channel in the fill running parallel with W1266. The channel is 9cm wide and 6cm deep. It curves away in a north westerly direction when it approaches the east-facing bench/extension of W1910.
- The fountain in the NW interior corner of the junction of W1226 and W1910 has a stone base 96cm from the top. The center of the pipe feeding the fountain is 36cm from the top. The base stone (marble) is broken in three parts and is 4.5cm thick. Plaster on the east wall extended to a lower level. On W1266 is a 20cm plastered shelf that proceeds 1.67m west and forms a corner. Its plaster proceeds to a lower level as well. This lower plaster to the east and to the south suggests that the fountain feeds some sort of pool.
