Hippus (Sussita) Excavations 2006 – 7th Season Daily Log + Drawing

Date: 16 July Area: NEC Manager: Schuler

Northeast Church Complex
Hippos 2006

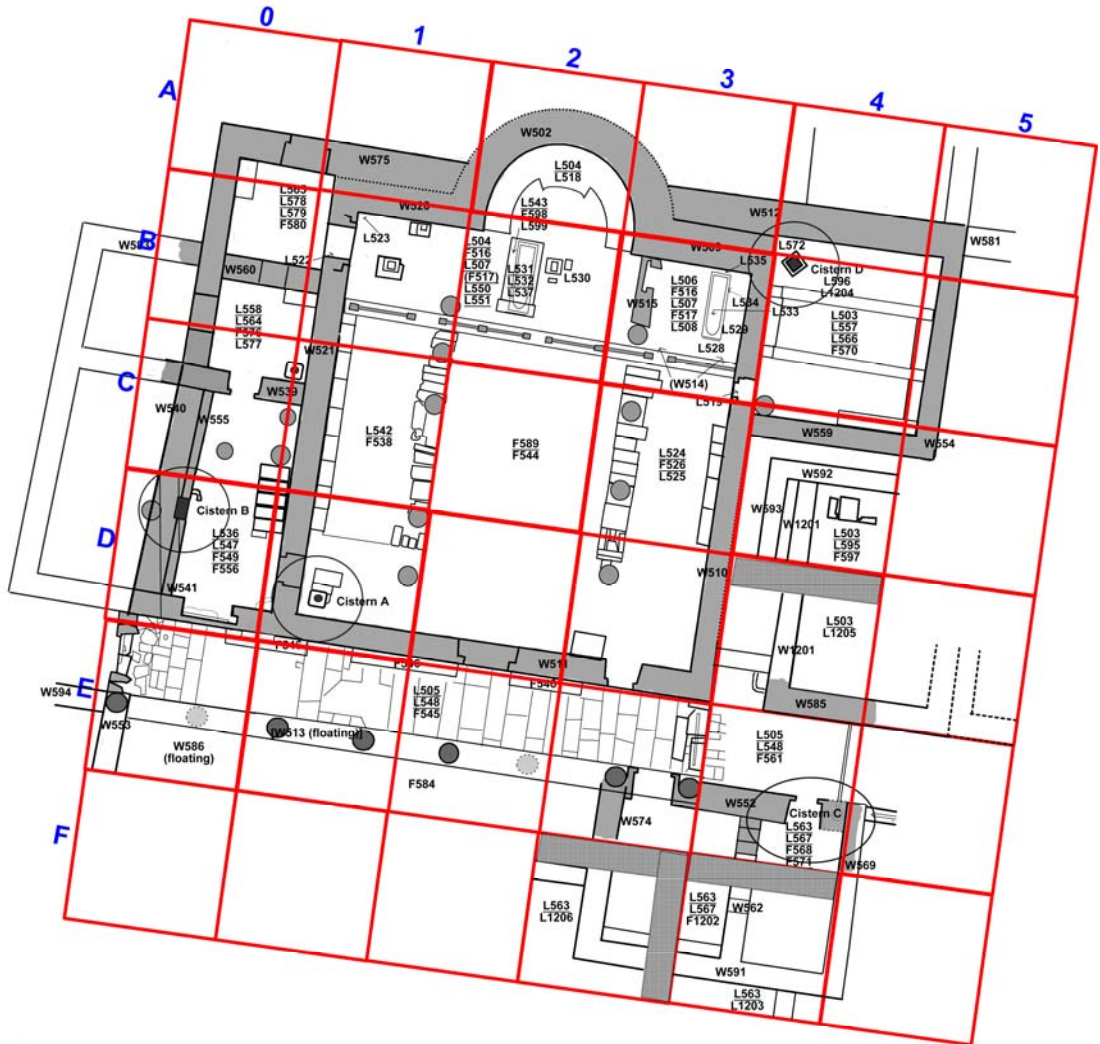
Daily Drawing

- Ending elevation = 130.760 (north of W1201 and east of ridge); 131.090 (top of ridge/low wall?)
 - Continued to clear area north of W1201.
 - There seems to be a low north/south ridge between W1201 and W510. It is 0.67m wide and about 0.35m high. It is 1.15m from the street.

- Where this ridge abuts W1201 on the west side there is a basin of some sort (compare similar basin in D0). It is a rounded quarter circle of hard plaster (0.60 x 0.60m)

- Soil is Horizon A to the north and B in the room.
 - Found a bench next to the west wall (W591) of same dimensions as in F4. The bench spans the north/south width of the room.

- In the SW corner of the square, there may be a wall going to the west (unnamed at this time). There does seem to be a north/south wall of poorer quality running to the north from W574. It is 2 meters from the west side of W591.
- Finished cleaning F4.
- Work on cistern D in Square B4 suspended due to evacuation of students
- Work on Square E8 suspended due to evacuation of students. Later in the season we may use the tractor to clear some of the top fill from the street in the E squares.
