Hippos (Sussita) Excavations 2006 – 7th Season Daily Log + Drawing

Date: 17 July Area: NEC Manager: Schuler

Northeast Church Complex
Hippios 2006

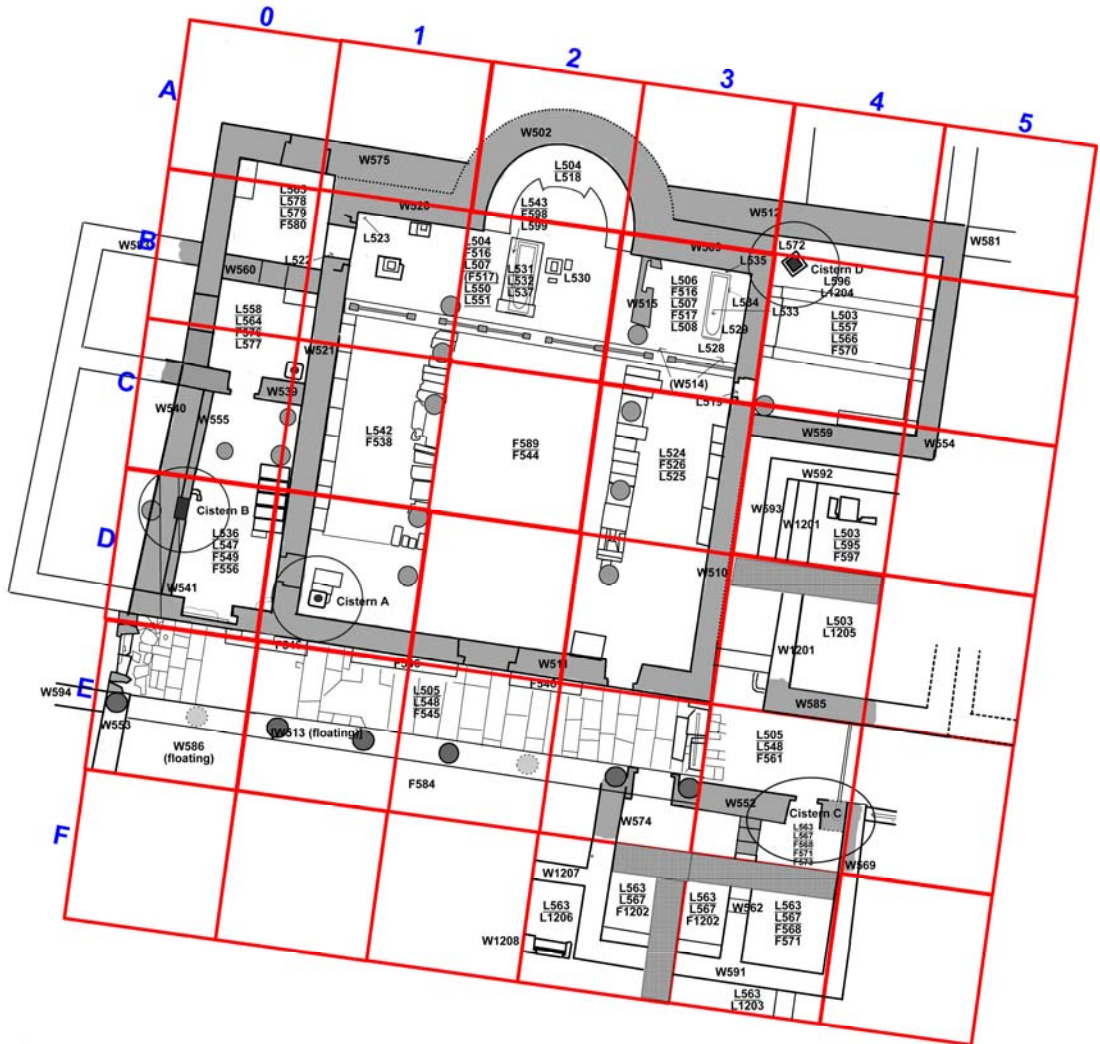
Daily Drawing

- Documentation of stone floor in F4
 - On the north side, there is a limestone frame on the floor 60cm wide and running the full width of 2.2m
 - On the west side the limestone frame runs for 1.7m from the Northwest corner. It is 50cm wide.

- In the northwest corner, there is a single basalt stone (20cm x 50cm), with the long dimension running north/south.
- Continued conservation work in Square C/D2 (Nave)

- There is a stone floor east of the ridge and a less defined floor to the west. The function of the ridge/wall is uncertain. If it is a wall, it creates an enclosed and inaccessible space.

- Ending elevation = 130.391 (north room facing west); 130.881 (east of new room); 130.701 (F1202 in F3)
- Soil is Horizon B in the rooms and A in the northeast corner.
- Discovered a doorway and continuing wall on a north/south line from W591. It has been designated W1208. The room is to the east. Two feeding troughs (partial) were recovered from the fill, as were two nails. As the room is clearly defined, we designated the eastern wall of the room as W1207, a poor quality wall perpendicular to and running north from W574.
- In the southeast segment of the square, we got to the level of F1202. But its plaster is more heavily damaged than that south of the balk.
- In the northeast corner of the square, we removed the balk (to allow removal of an unornamented lintel stone from the fill). We exposed the top of W574 and removed other surface fill.
