Hippos (Sussita) Excavations 2006 – 7th Season Daily Log + Drawing

Date: 18 July Area: NEC Manager: Schuler

Northeast Church Complex
Hippios 2006

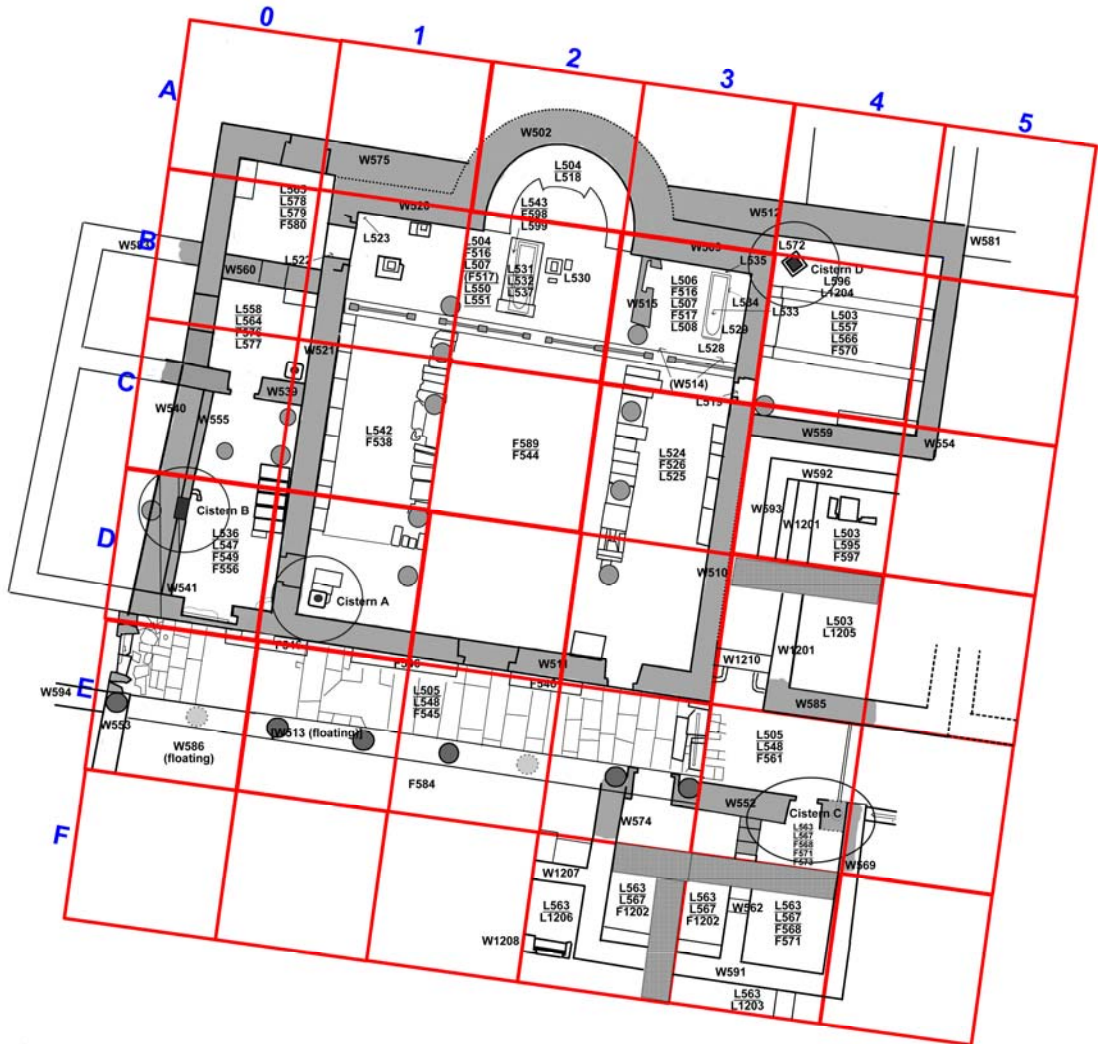
Daily Drawing

- Ending elevation = 131.200 (south of W1201)
 - Soil is Horizon B
 - North of W1201 there is stone paving to the east, then a low wall (W1210) 60cm wide.

- In the SW corner of W1210 and W1201 there is a basin with a drain running to cistern C (presumably)
 - In the NW corner of W1210 and W510 is a similar basin. Its drainage is uncertain. We presume these two basins are the reason for the low wall (W1210).

- East of W1207, we recovered a limestone shelf inscribed with a flaired cross. We also removed a lintel stone from the fill.
- On the east side of W1207 and abutting it is some sort of structure (bench/step) of uncertain function. It seems too wide for a bench (in comparison with other benches on the site).

- East of this structure is a plaster floor at a level above the stylobate. Perhaps it was connected with the earlier floating wall (W513).
