Hippos (Sussita) Excavations 2008 – 9th Season Daily Log + Drawing

Date: 3 July 08 Area: NEC Manager: Schuler

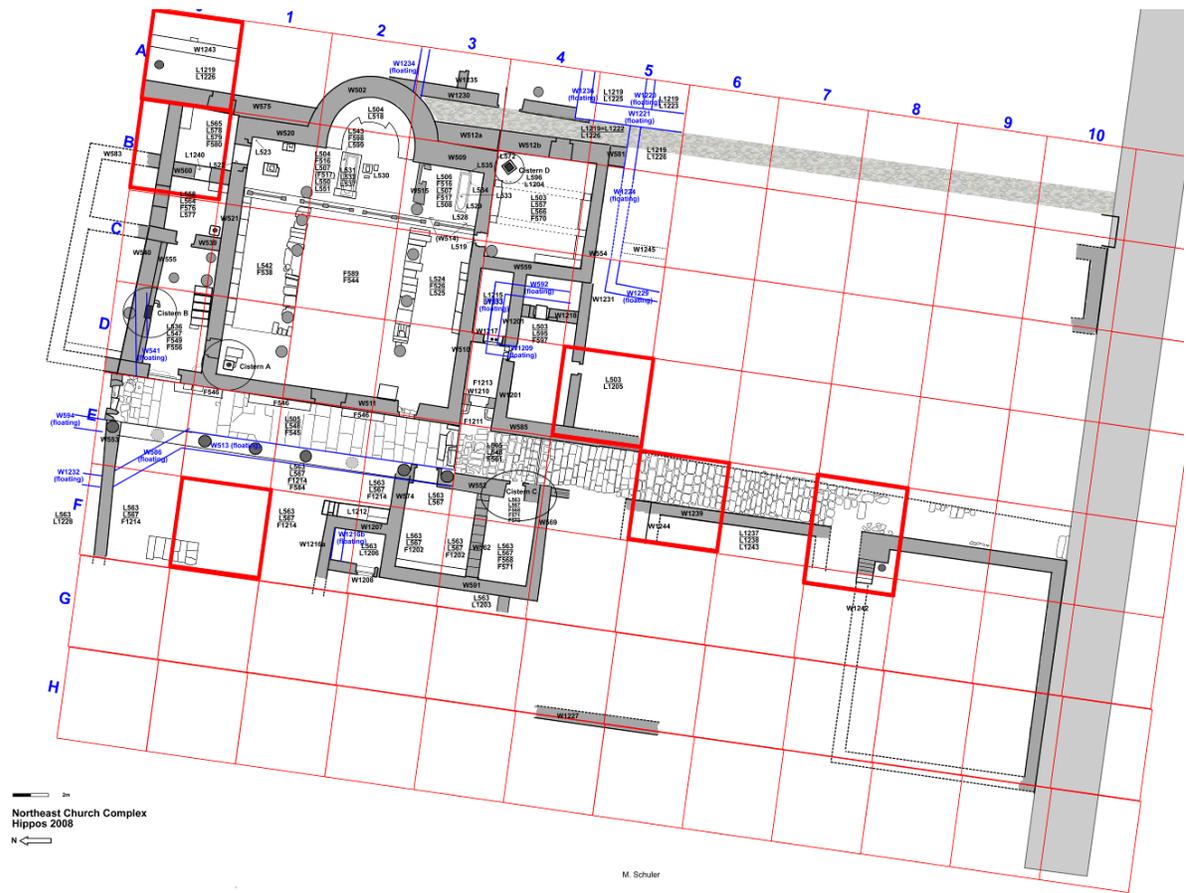
Final Drawing

20
Northeast Church Complex
Hippos 2008
N ←
