Hippos (Sussita) Excavations 2012 – 13th Season Daily Log + Drawing

Date: 12 July 2012 Area: NIP Manager: Schuler

Squares	DH39	DI40	DJ40	DR42
Loci	2107	2138	2106 2109	1914
Baskets	3110	3111	3112 3113	3114
Walls 1224, 1244, 1266, 1285, 1386, 1945, 1949, 2007				
Floors 2110

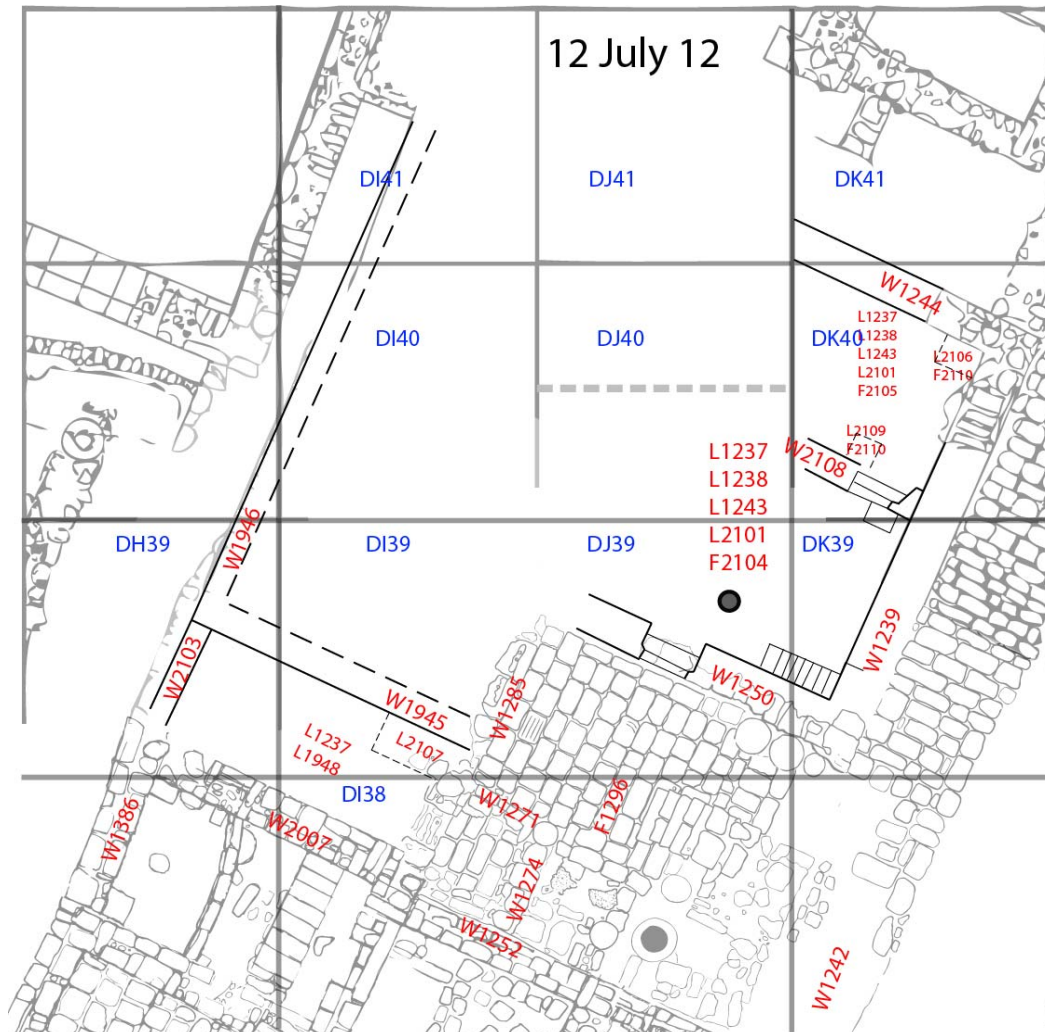
- vi) Continued to lower probe in L2107 (2 x 1.4m).
- vii) Inside is a square basin 46 cm across and 20 cm tall
- viii) Also a grinding bowl (shallow)
- ix) Two flat stones of indeterminate function sit west and south of the basins in a perpendicular form

(11) Description: Large square bowl found in northeast corner of room in probe.

Assumed to be sitting on floor. Walls of bowl have a thickness of 8 cm, depth of bowl measures to 27 cm.

- (4) State of Preservation: Nearly complete
- (5) Width: 44.0
- (6) Length: ---
- (7) Depth/Thickness: 22.0
- (8) Elevation: 128.20
- (9) From east edge of square: 2.3
- (10) From north edge of square: 5
- (11) Description: Found directly south of square bowl in northeast corner of the room.
Sitting on large, flat rock.

- x) Coarse ware and moderate quantities of bone with small quantities of glass fragment and a few tesserae were recovered from the fill.
- xi) Repairs were conducted on the collapsed corner of W1386 and W2007. Slanted foundation stone was reset and the initial course above it to the west.

- xii) The weakened junction between W1285 and W1945 received two courses are reinforcement. A doorjamb was set on the south end of W1285
- xiii) Ceramic analysis

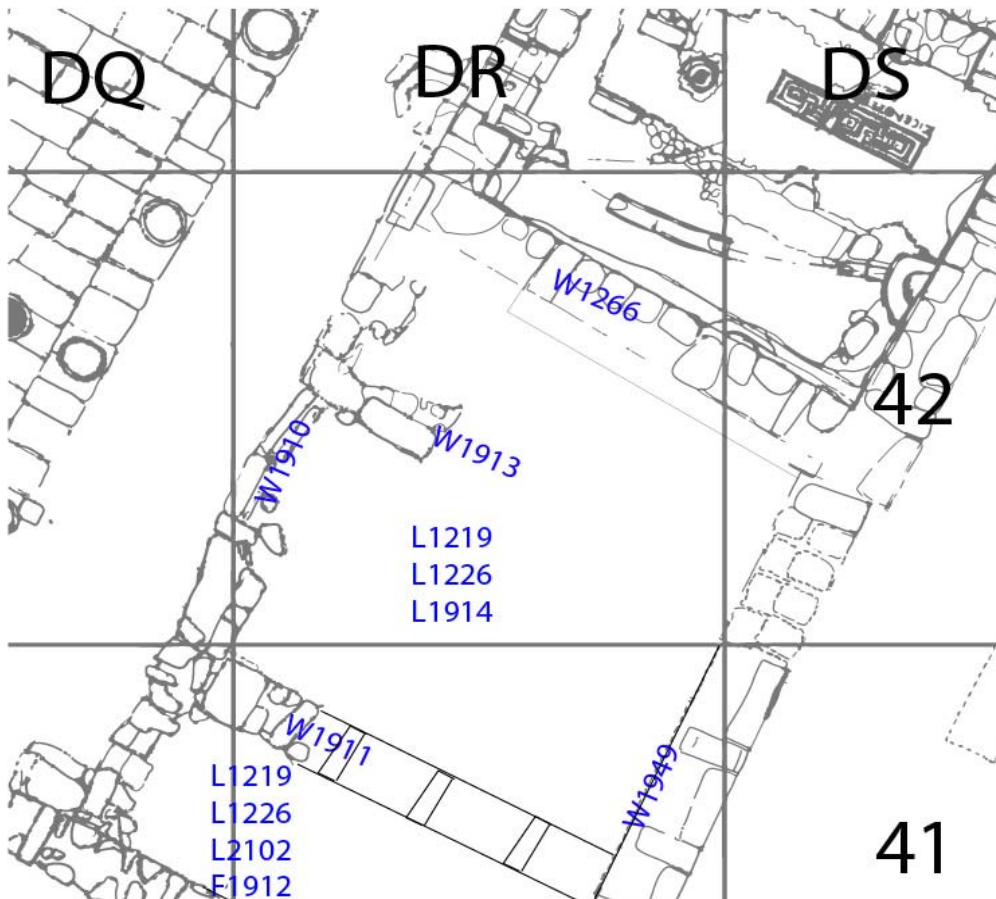
- vi) Several more pieces of a large stamped plate similar to or part of one previous recovered were found in the fill.
- vii) A line of east to west stones immediately south of and parallel to W1266 seem to be a shelf of some sort. They seem too high to be a bench. Fragments of plaster and perhaps a few tesserae cling to the top of the shelf and may rise up the south face of W1244. Considerable loose tesserae were recovered above and in front of the shelf.
